## HAMILTON LAKE DAM

NDS ID NO. PA-33

### PHASE I INSPECTION REPORT NATIONAL DAM INSPECTION PROGRAM

SEPTEMBER 7, 1979

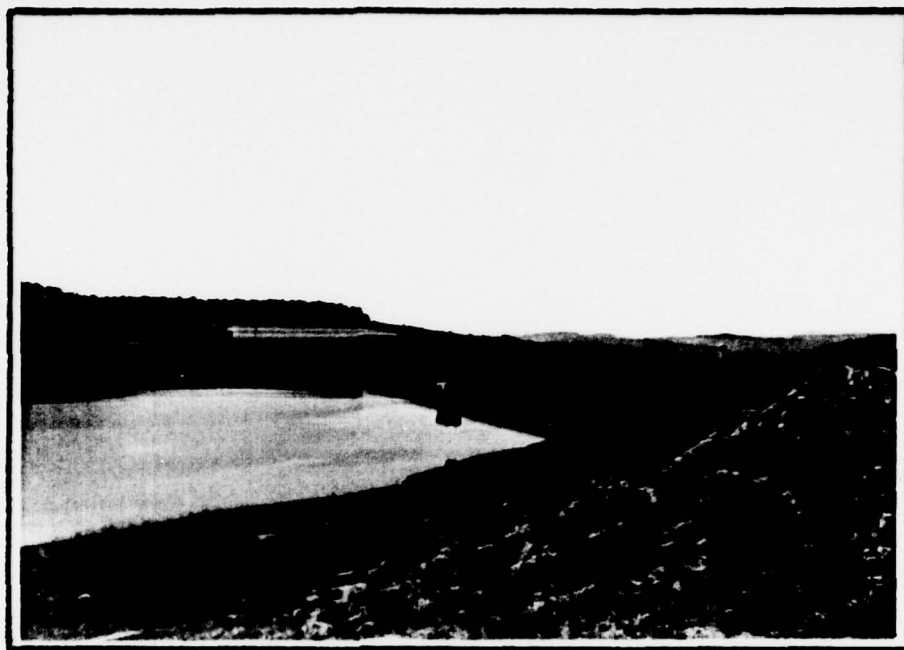
Overview of upstream slope of dam.

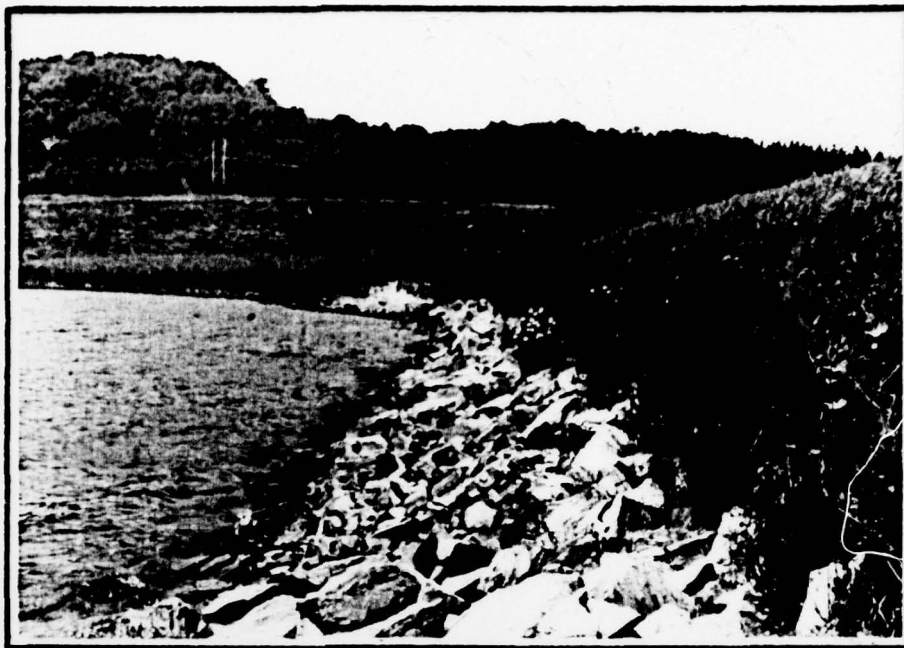
Upstream slope of dam showing riprap and emergency  
spillway approach.

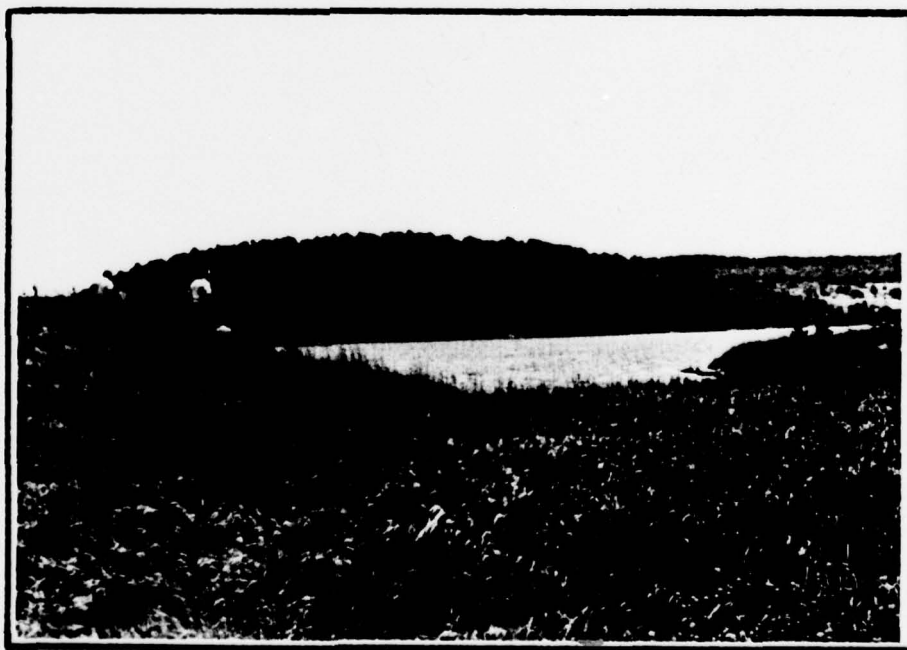
Emergency spillway approach channel.

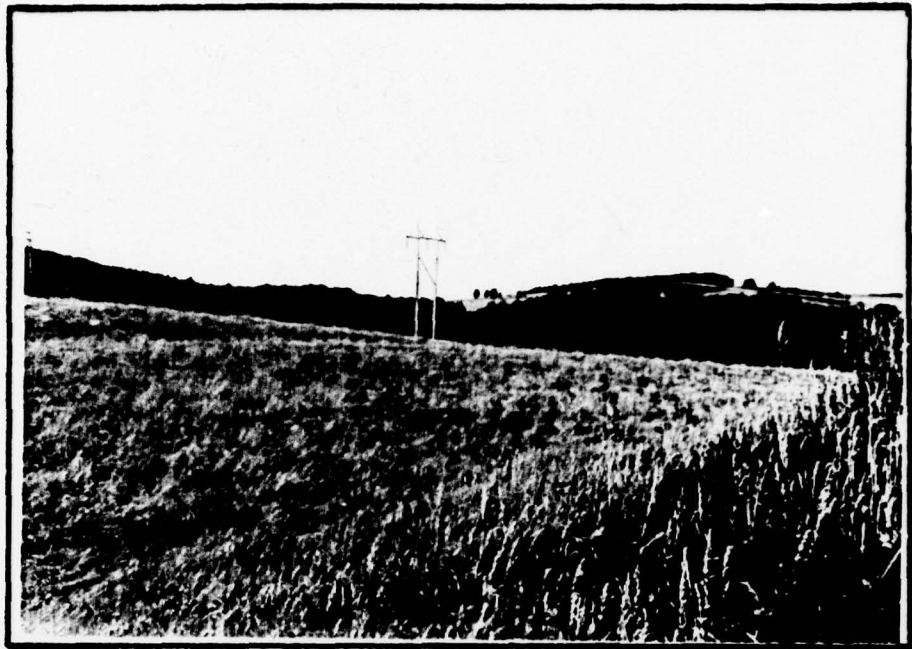
Emergency spillway discharge channel.

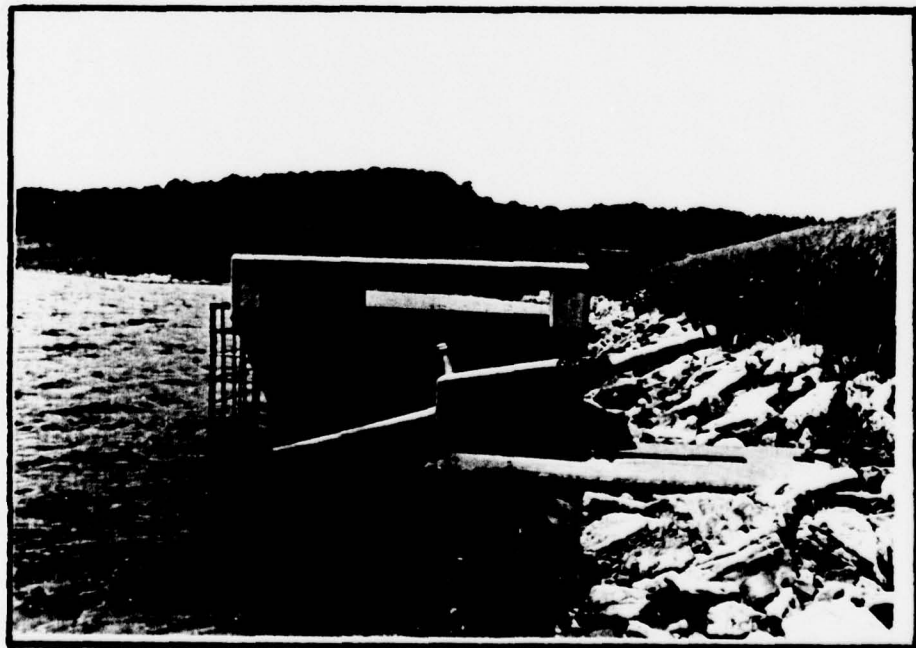
Principal spillway, orifice invert and drain line stem.

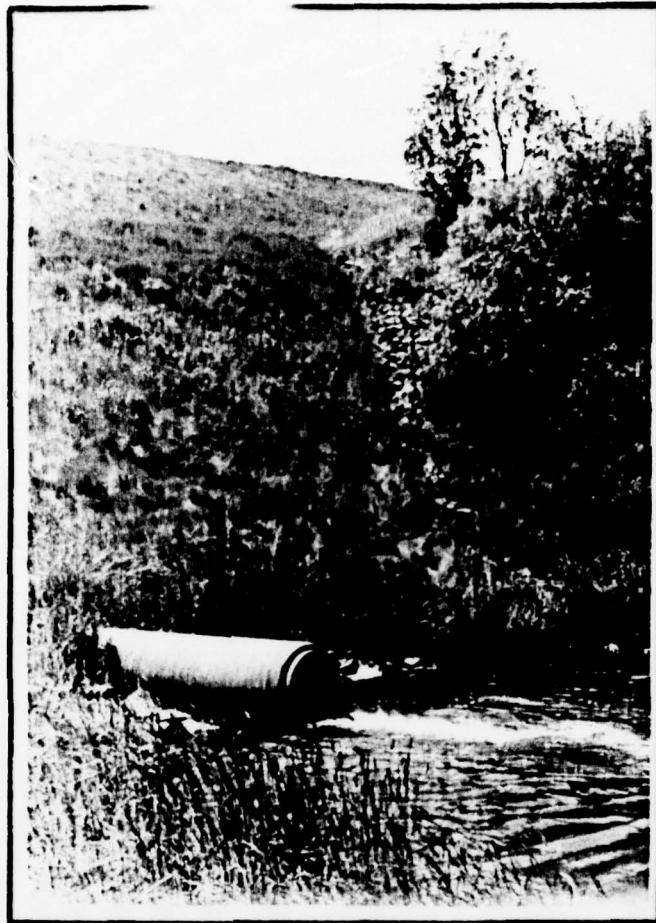
Outlet works and principal spillway discharge.

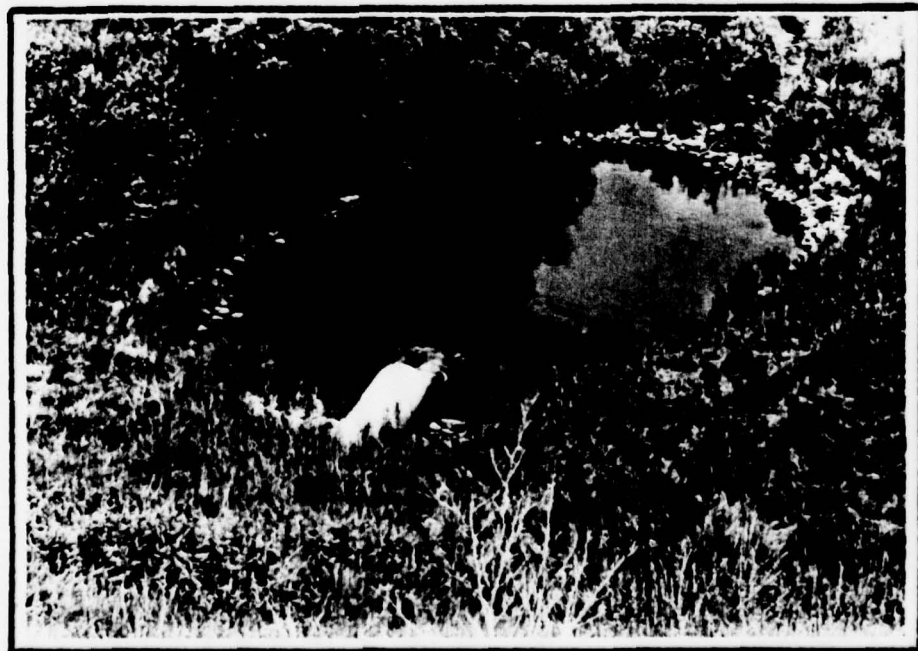
Tailwater at outlet works discharge.

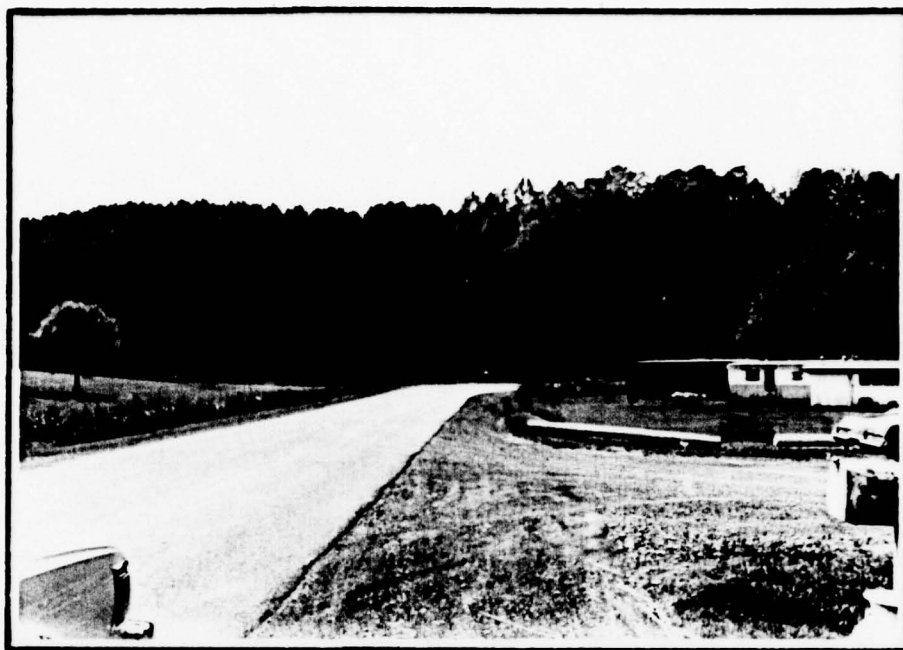
First downstream residences.

2. A warning system should be instituted to warn downstream residents of large spillway discharges or failure of the dam.

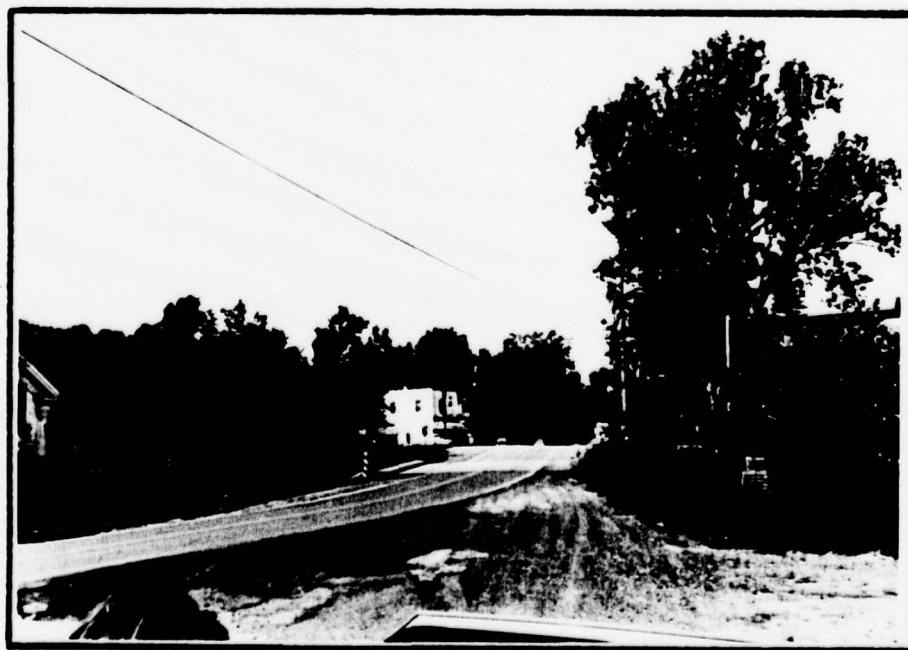
Downstream residences.
